# EVERPINE GROUP CO., LTD. TEST REPORT

UL 10C-2016 (R2021) TESTING ON VISION LITE FRAME, MODEL VP660X1676 IN A STEEL DOOR

230330002SHF-001

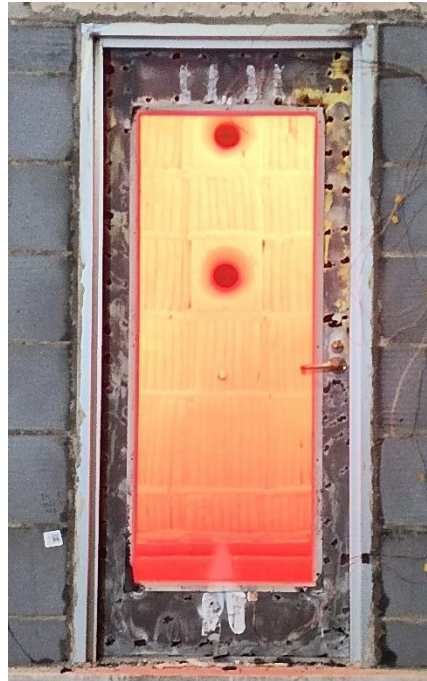
Fig. 5 Unexposed Side after 90 Minutes

During the 90 minutes fire exposure period no flaming was observed on the unexposed face of the assembly. This assembly therefore met the criteria of the test standards for flaming. No through openings or penetrations were evident at the conclusion of the fire exposure portion of the test.

The glazing assembly remained in the opening of door leaf without any separation and glass breakage and did not loosen from its fastenings.

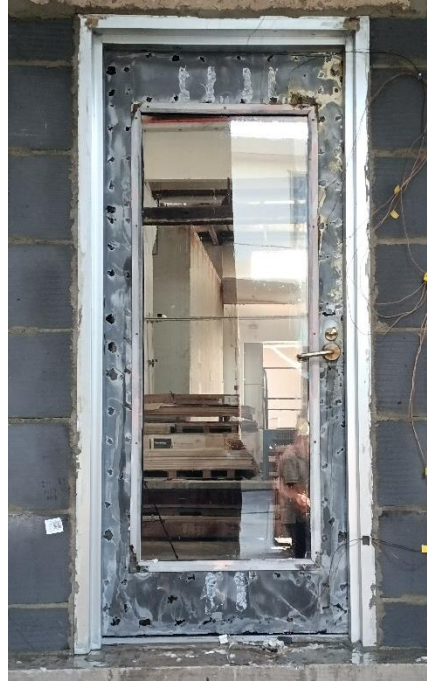
Fig. 7 Unexposed Side after Hose Stream Test

After the hose stream, no through openings were apparent and the door latch remained engaged to the strike. The measured deflection of the edge adjacent to the door frame neither exceed the allowable deflection limit of 1-1/2 times the door thickness, nor more than 67.5 mm after the hose stream test.

The glazing assembly remained in the opening of door leaf without any separation and glass breakage and did not loosen from its fastenings.
